The Road Inventory of Crescent Lake National Wildlife Refuge Ellsworth, NE

Prepared By:
Federal Highway Administration
Central Federal Lands Highway Division
May 2008

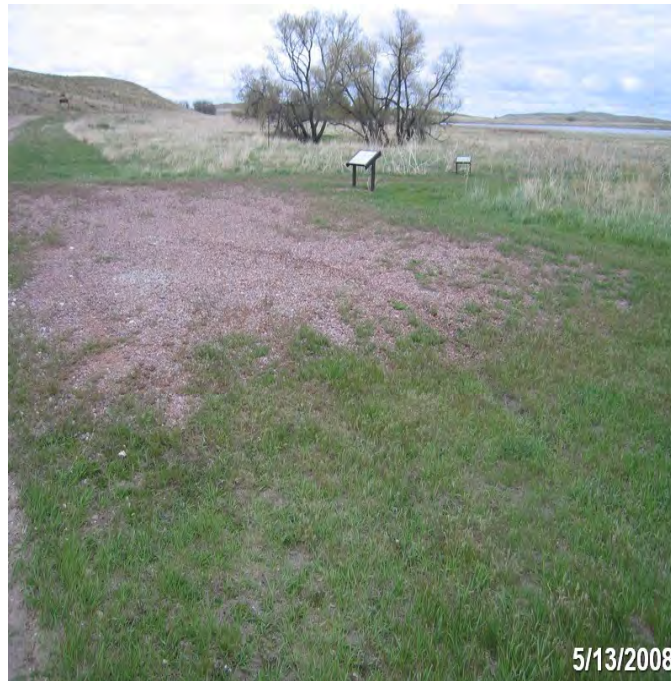
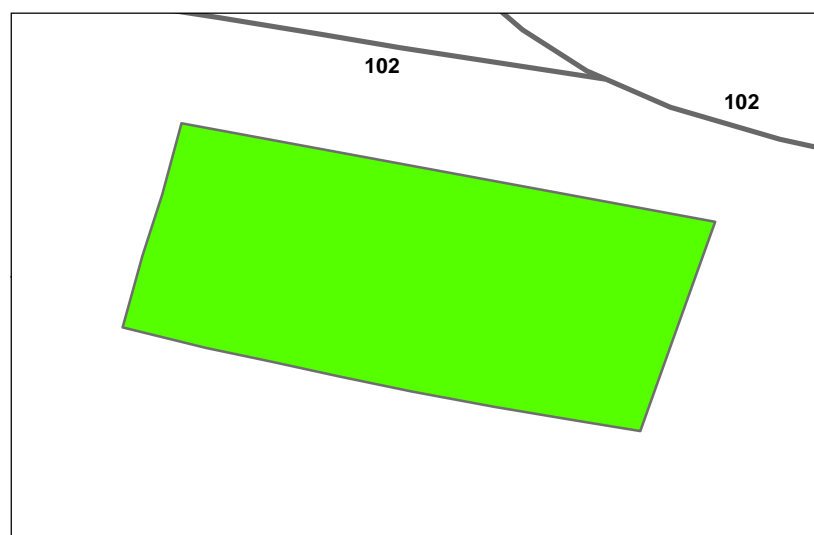
Route 919: Wildlife Trailhead Parking

Asset Number	Date Visited	Surface Type	Area (sq ft)	Condition	Cost to Improve
	5/13/2008	Gravel	1608	Good	\$200
